Bachelor-thesis

Investigation of a series of accidents involving yachts for diving vacations

degree: Naval architecture

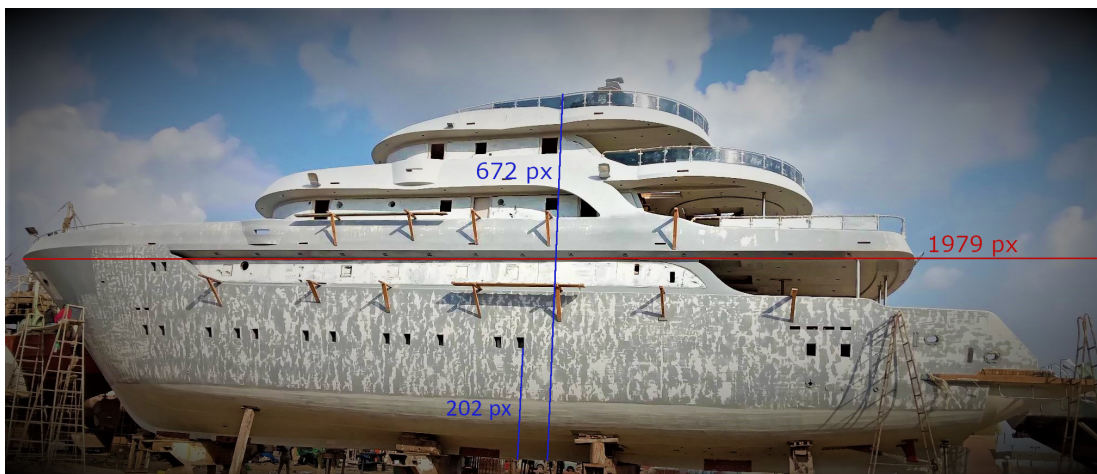
Figure 11: Measurement of the height of the Carlton Queen

With a length of 42 m and a width of 8.5 m, the „Carlton Queen“ was one of the larger liveaboard ships. To determine the height, the total height in pixels was measured from an image from the construction phase and compared with the known length in pixels (Fig.

A height of 14.3 m is obtained from the known length using a rule of three, ignoring both the perspective distortion of the image and the curvature of the bow. The calculated height should therefore only be regarded as an estimate. The ship was designed for 28 guests and a crew of 9.

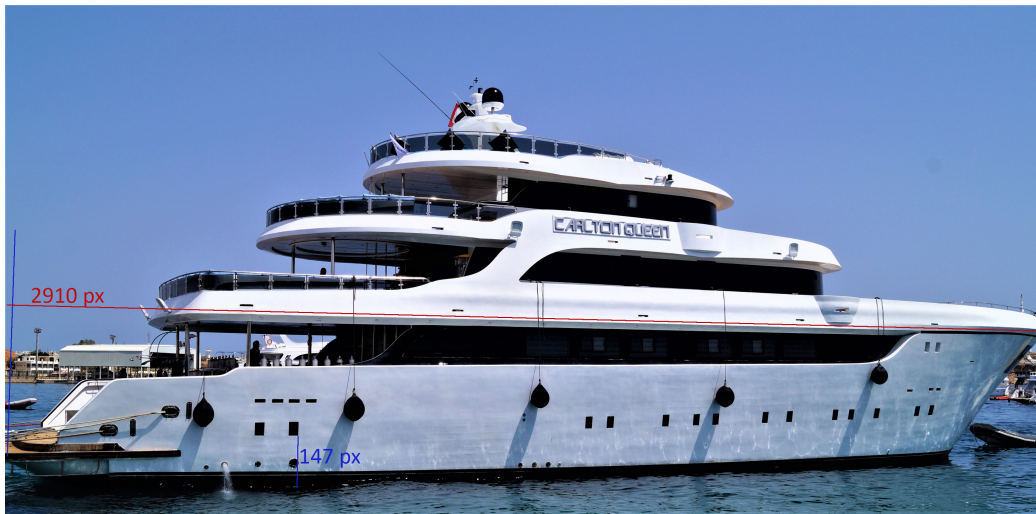
Figure 14: height of the windows

Furthermore, the windows in the showers on the lower deck could be opened [87]. If the state of closure of these windows is not sufficiently controlled, water can very easily penetrate through such an open window, even if it is weather or watertight when closed.

If the length of the ship is taken as known and measured with 2910 pixels in length in the image, an estimate of the height of the windows above the water surface can be made. This does not take into account the perspective distortion of the image or the curvature of the bow. This is therefore only a rough estimate. A rule of three with these measurement results gives a height of the windows above the water surface of only 2.1 m. Similarly, from Fig. 11 that these windows are 4.3 m above the keel. This low height leads to possible water absorption even with small rolling movements or high waves if the windows are open or not completely sealed. Water absorption rapidly reduces stability, as the windows represent a leak in such a case. However, water is only reported in the lower deck after capsizing. As the windows were small and you couldn't stick your head through them [87], they are treated as portholes here, although it is not possible to measure their exact size. According to the Convention on Load Lines, portholes are a maximum of 0.16 m^2 in size and may not be installed below 0.5 m above the summer load line. In addition, they may only be opened if the result of the leak stability calculation shows that the porthole does not submerge even in the event of a leak [98, Annex I Regulation 23]. Since a corresponding leakage calculation is not available, it is not possible to assess the extent to which this regulation was complied with.

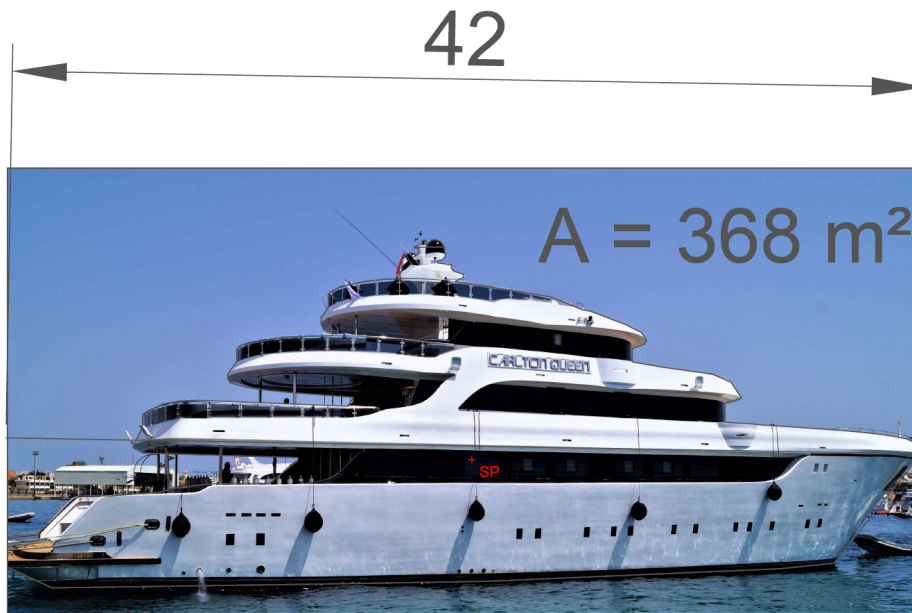
Figure 15: Page lateral surface determined from AutoCAD

To estimate the heeling moment due to wind, the lateral area was determined from a lateral image of the „Carlton Queen“ (Fig. 15).

The determined area can only be roughly compared with the actual area, as the perspective makes it much more difficult to determine. The shooting angle from aft visually shortens the ship and reduces the size of the bow by adding depth. In addition, the upper decks cannot be depicted well, as the covered deck areas are shown larger when viewed from below. These were depicted with a larger area, as this reduces the effect of image depth. The center of gravity marked in red is at a height of 5.8 m. This position is not exact due to the aforementioned problem. However, the distortion has a much greater influence on the position along the length of the ship. Therefore, an estimated value for the wind moment is calculated using this area and center of gravity position. A wind pressure of 115 Pa or 38 Pa is calculated, which corresponds to a wind force of 6 bft or 4 bft [100]. These wind forces were chosen because 4 bft corresponds to the average wind speed on the day of the accident and 6 bft in a gust is still realistic for that day. This results in a heeling moment of 81 kN for the average wind and 245 kN for gusts. With the previously calculated displacement, this corresponds to heeling levers of 0.569 m and 1.72 m according to Meyer-Bohe [99, p. 39]. With the assumed \overline{GM} of 0.3 m, these lead to angles at which the small angle approximation [99, p. 13] is no longer applicable.

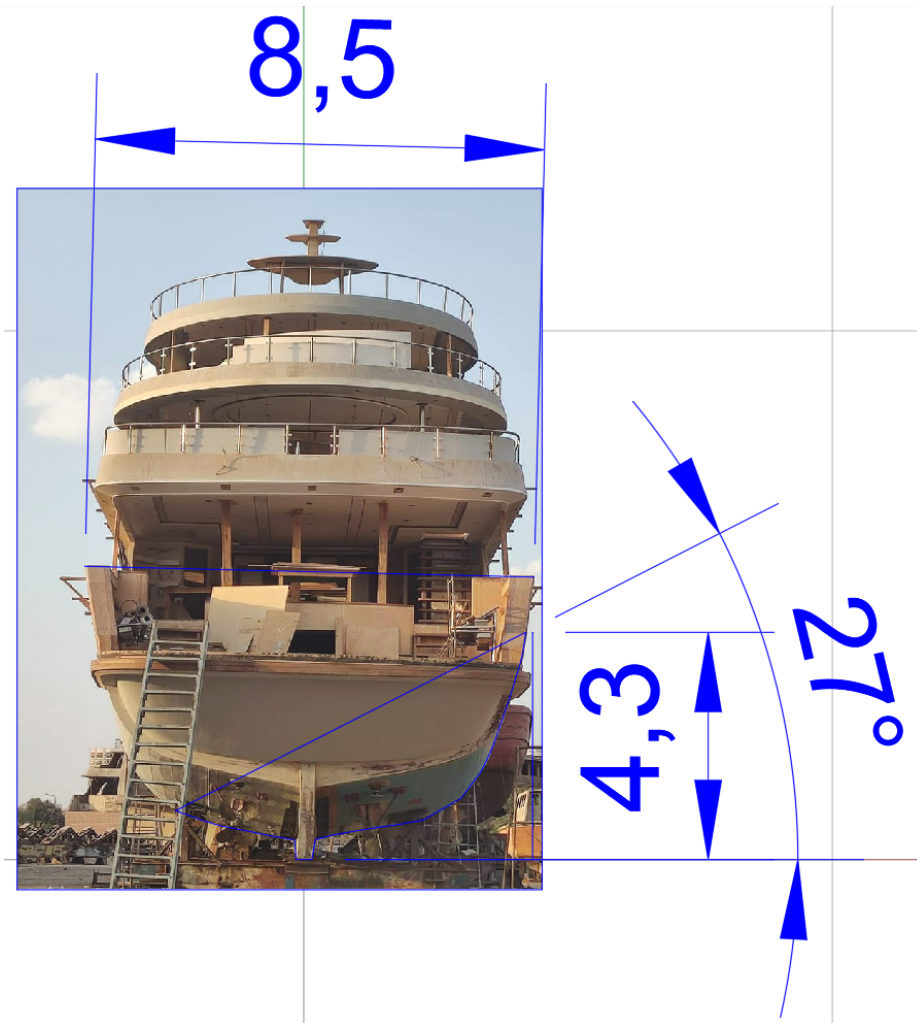
Figure 16: Angle at which windows reach water determined from AutoCAD

From the stern view with the frame for the \overline{KB} (Fig. 24), a minimum angle can also be calculated at which the windows come to water, whereby waves are not taken into account. A curved frame is drawn for this. This has the same area as the frame without heeling and

has the height on the starboard side up to the lower edge of the windows (4.3 m), as shown in Fig. 11 can be determined by pixel measurement. The area must remain the same so that the displacement does not change. Changes due to the shape of the ship are ignored, which can also result in trim angles or a slightly different angle. In order to determine these changes, pantocarenes and a more extensive stability calculation would be necessary, for which the data is missing. The angle resulting from this analysis is 27° (Fig. 16). This can be significantly reduced by waves, as they partially overcome the height above the water. This is low for windows that are to be opened given the low initial stability of the „Carlton Queen“.

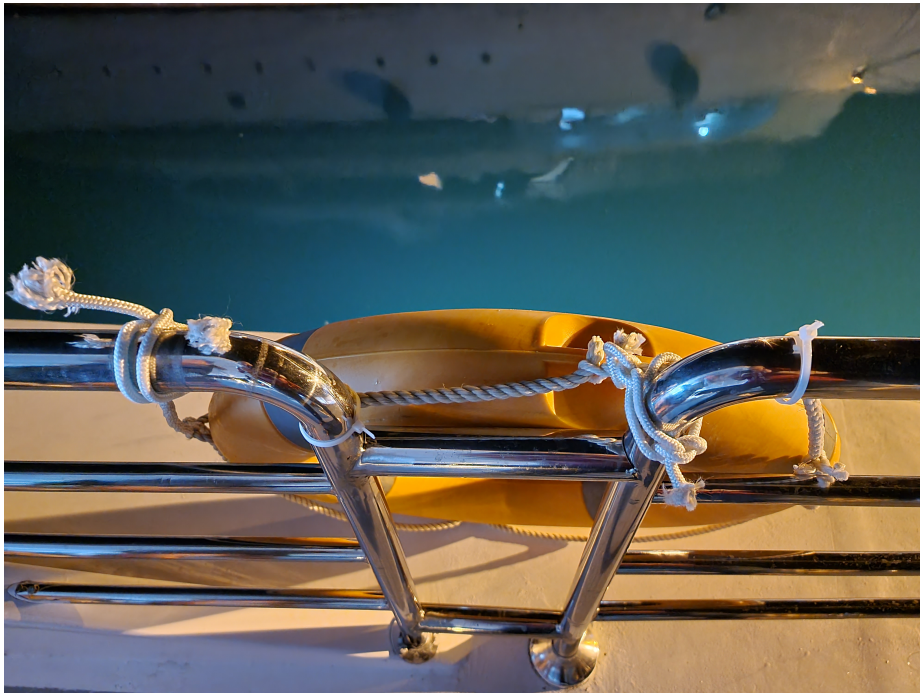
Figure 17: Lifebuoy attached to the „Emperor Elite“ with cable ties

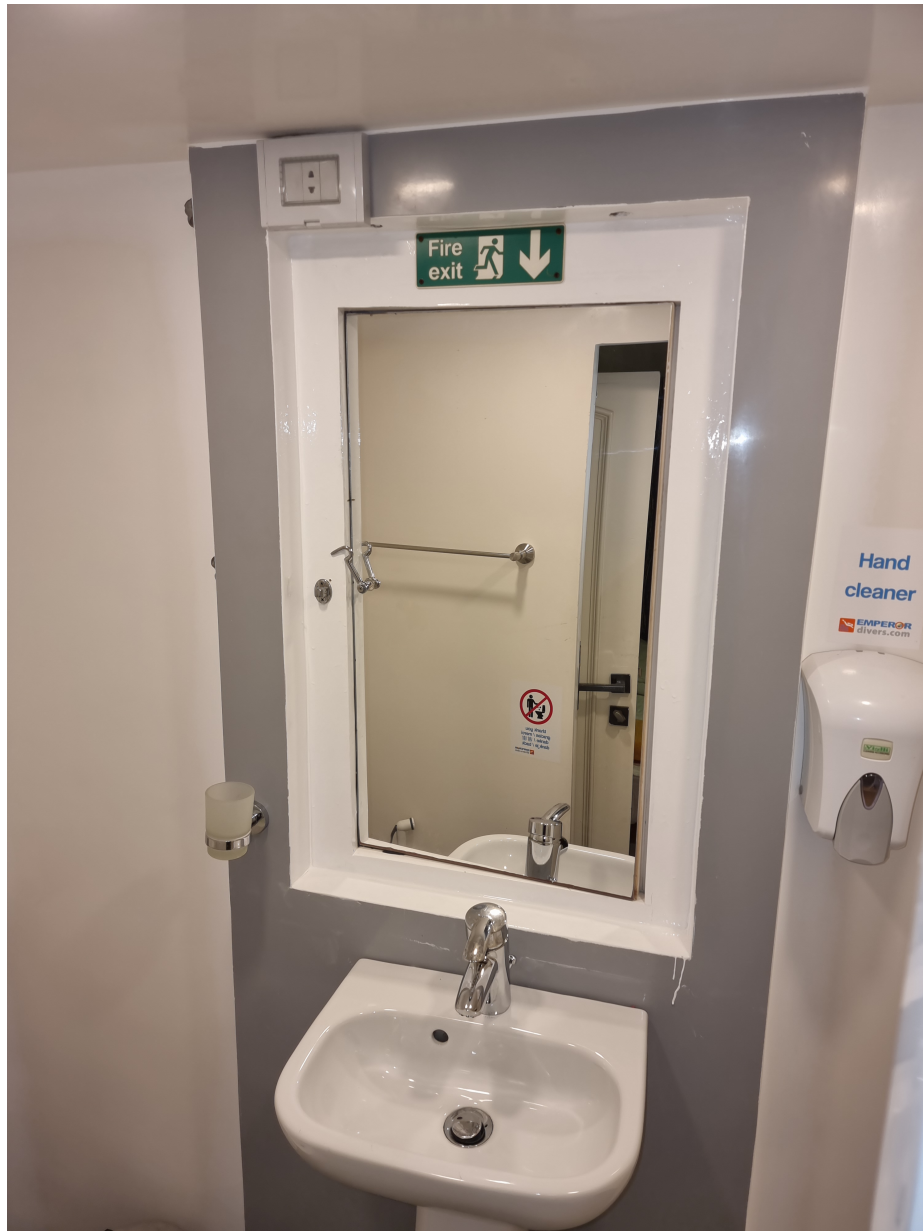
Figure 25: Mirror as emergency exit on the „Emperor Elite“
