***INSPECTION REPORT FOR FIREFIGHTING
APPLAINCES ONBOARD***

M/Y “EMPEROR ELITE”

PORT GHALIB
MARSA ALAM,
EGYPT

ON
24th July, 2025

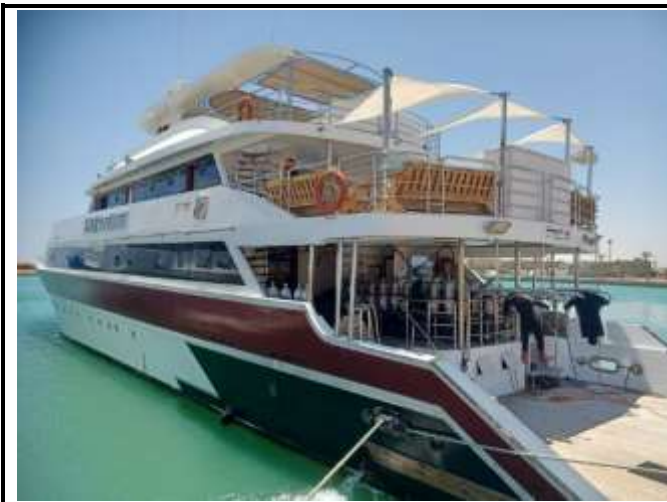
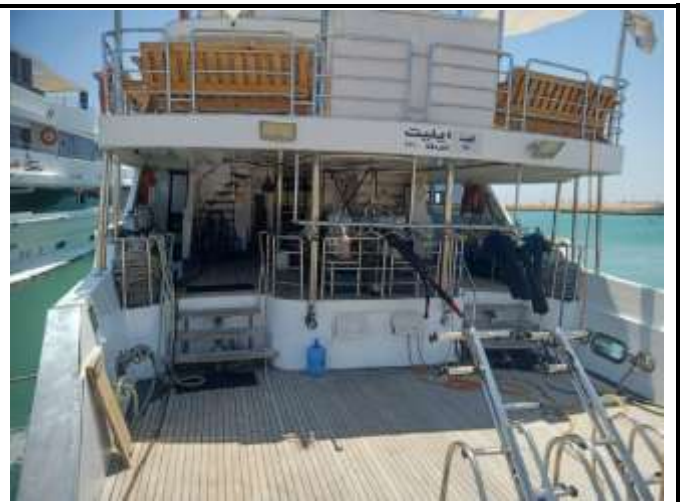
A thorough visual inspection was carried out across all accessible areas of the liveaboard yacht, including guest accommodations, crew quarters, galley, engine room, safety equipment stations, communal areas, exterior hull, and all deck levels. The vessel was found to be in overall satisfactory condition, with no visible deficiencies, safety hazards, or structural irregularities observed at the time of inspection. Housekeeping standards were well-maintained, and all accessible systems, fixtures, and fittings appeared to be well-maintained and in sound operational condition.

The navigation equipment—including the GPS, radar, and VHF communication systems—was visually checked and found to be in place and generally well-maintained. However, it was observed that the echo sounder was not functioning properly during the inspection, as no depth reading was displayed on the unit. This issue should be investigated and rectified to ensure safe navigation, especially in shallow or unfamiliar waters.

- Investigate and rectify the malfunctioning echo sounder to ensure navigational safety.
- Update the firefighting equipment certificate to reflect the actual onboard inventory and replace the expired fire extinguisher balls.
- Maintain proper documentation of fire drills and safety briefings for audit and verification purposes.
- Ensure regular review and verification of safety equipment inventory against certification records to maintain compliance.

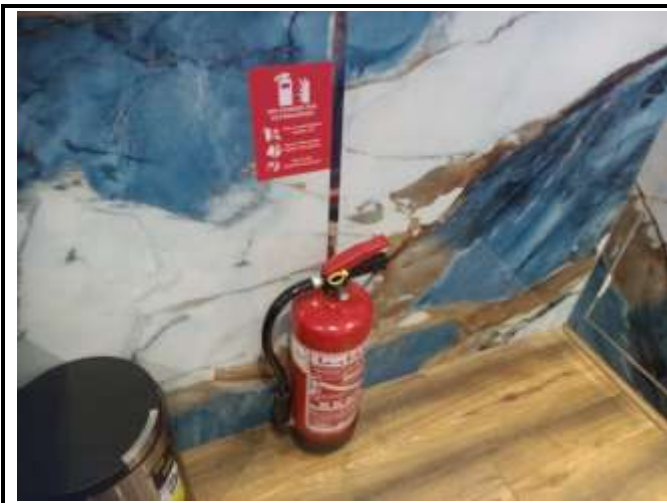
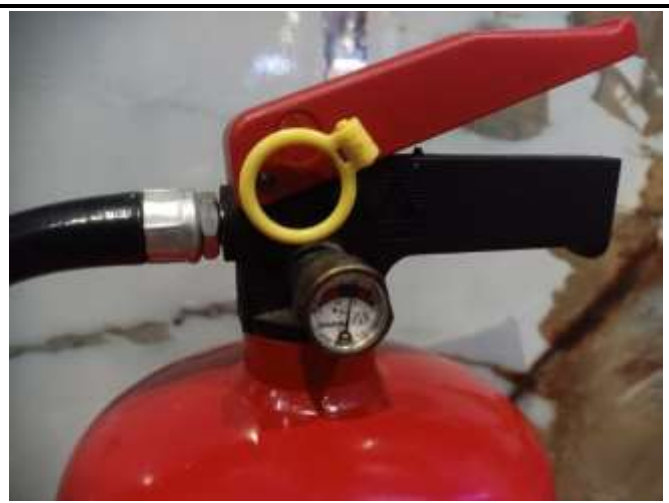
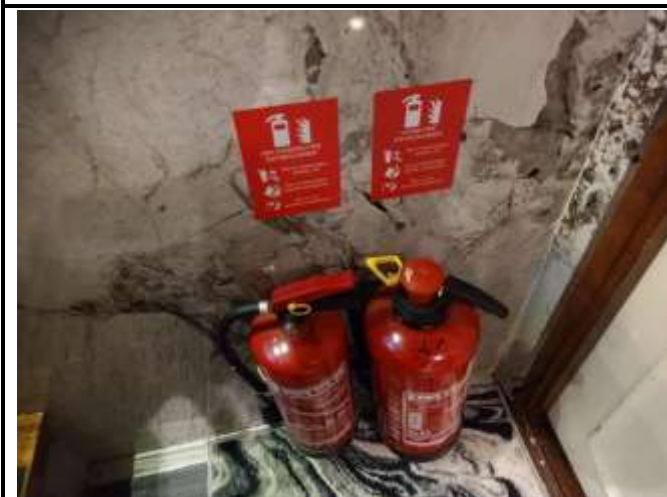
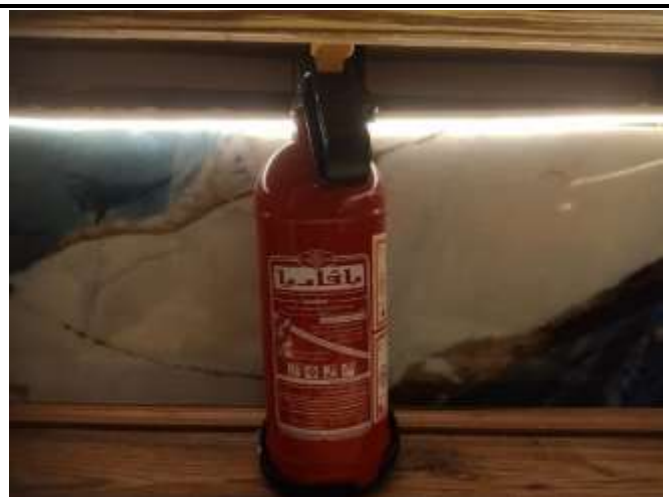
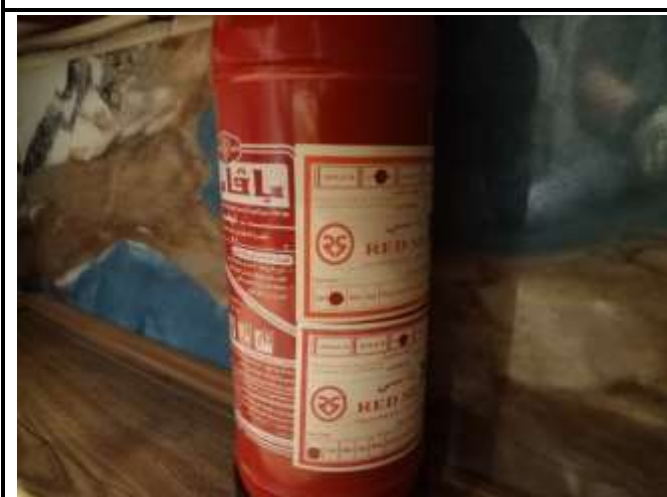
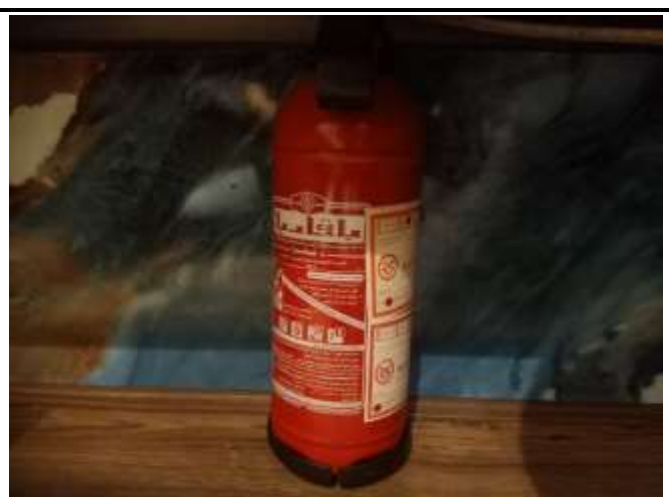
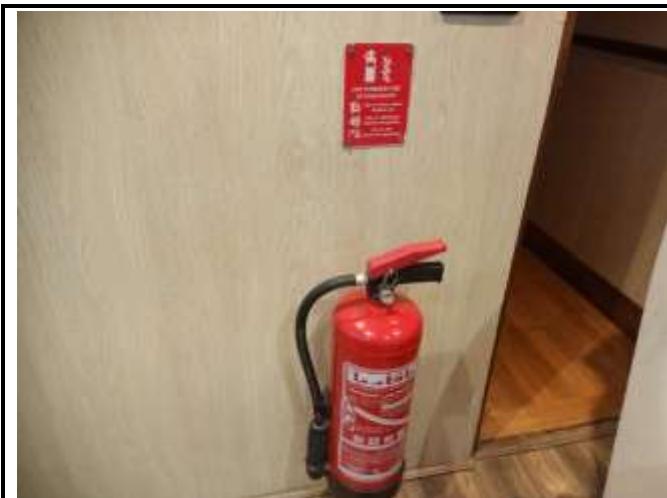
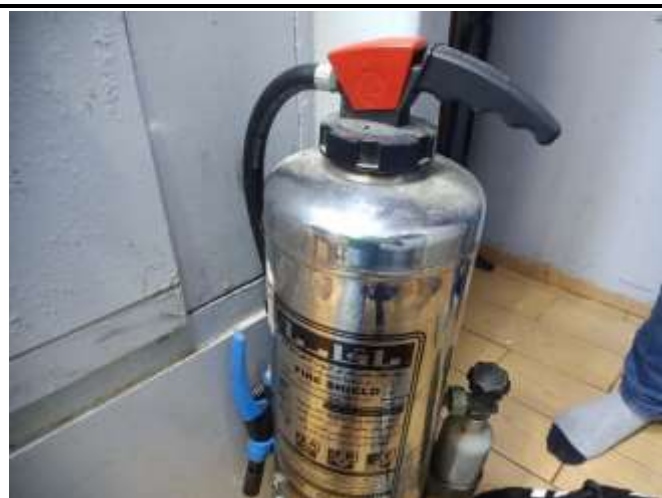
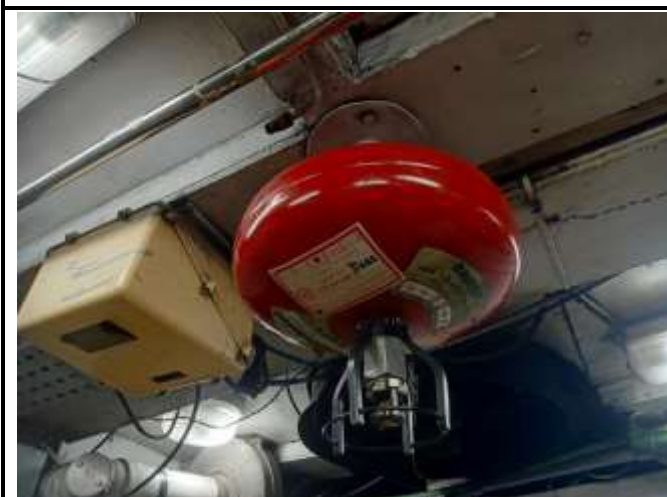
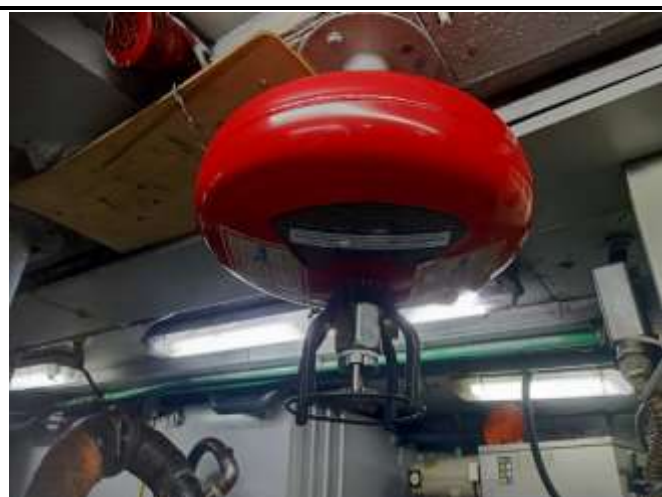
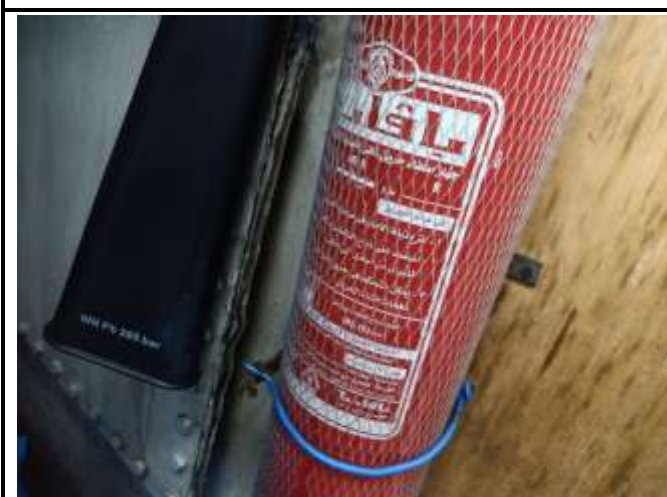
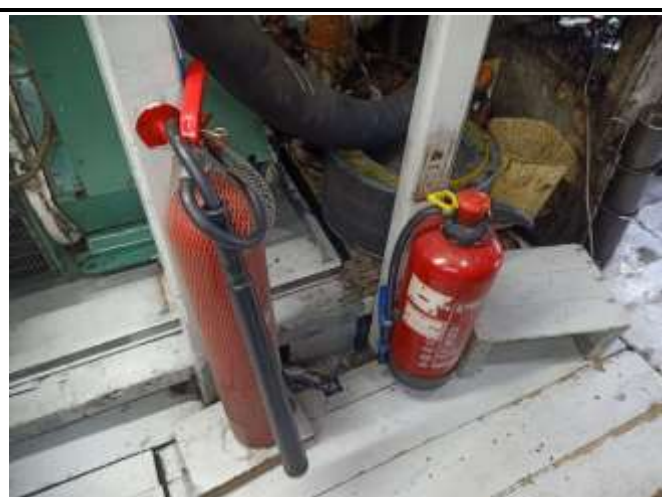
It should be noted that the certificate states that the yacht is equipped with three 9 kg dry powder fire extinguishers; however, only two units were located onboard during the inspection, positioned as indicated in the previously provided table. In addition, two 6 kg CO₂ fire extinguishers were found installed inside the engine room, though these were not listed in the certificate. This discrepancy between the documented and actual firefighting inventory should be addressed to ensure compliance and accurate recordkeeping.

All portable fire extinguishers found onboard were in good condition. Pressure gauges indicated correct charge levels, safety pins were securely inserted, and tamper seals were intact. No signs of damage or irregularities were observed during the inspection.

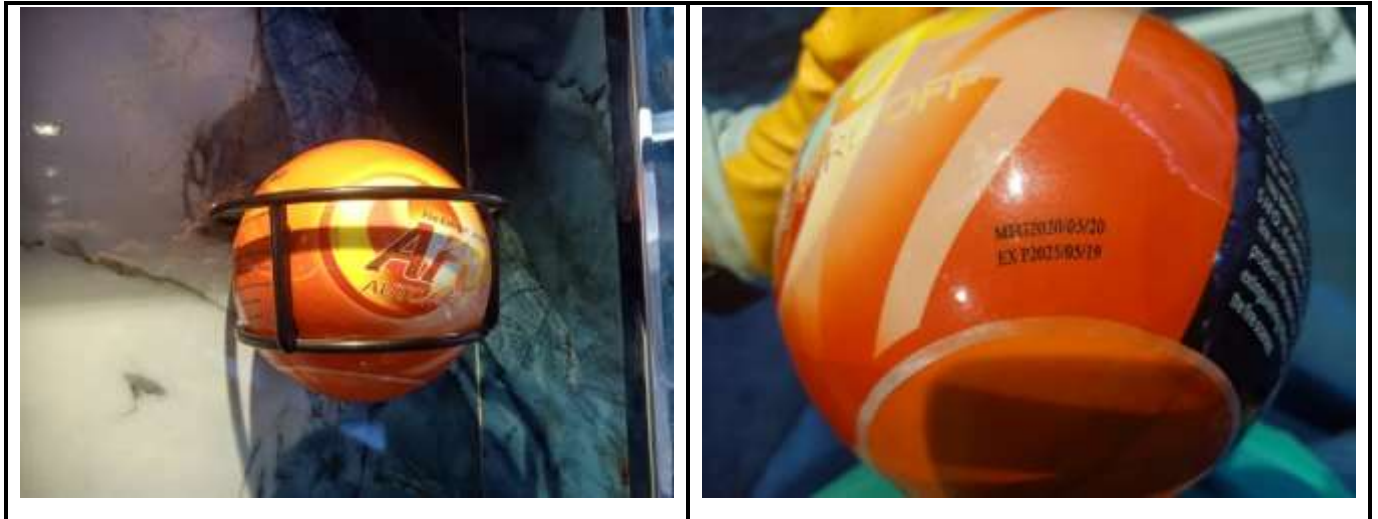
The yacht is also provided with **two fire extinguisher balls**, both are located in the saloon and both were found expired.

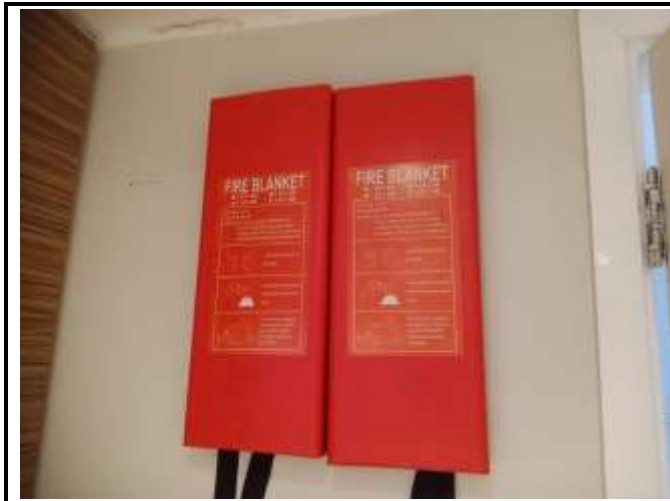
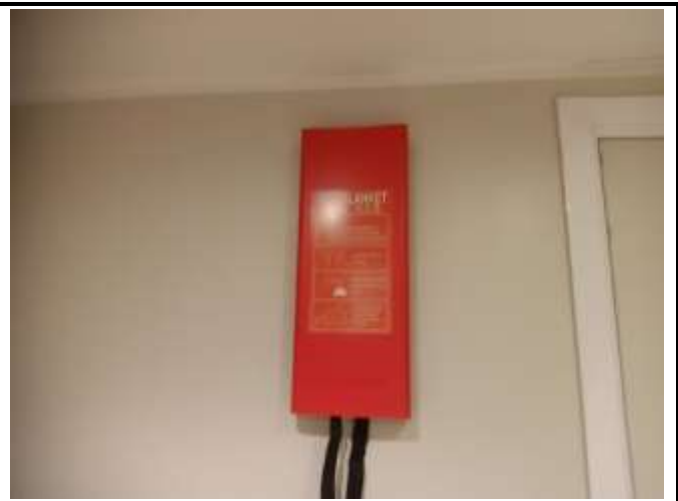
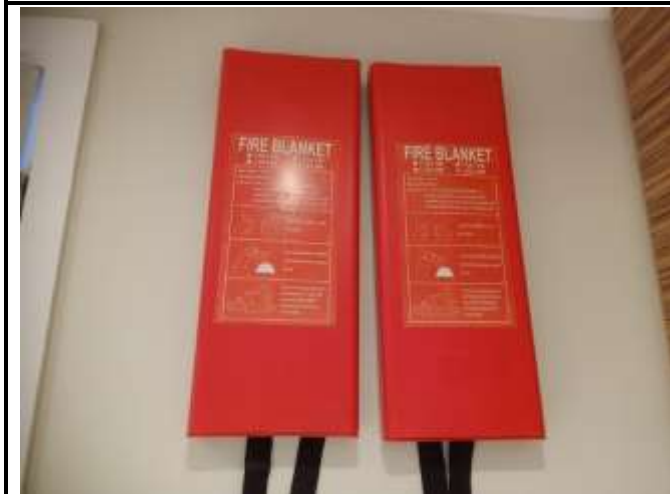
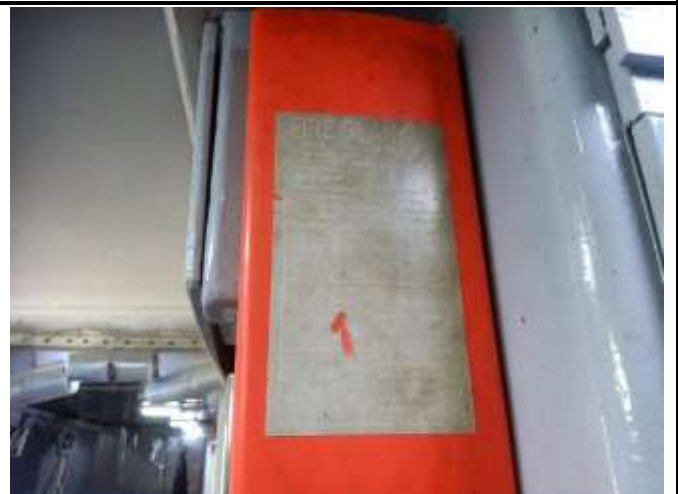
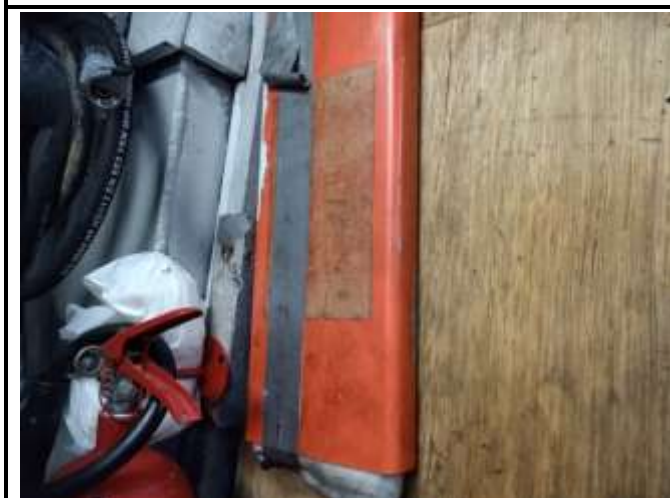
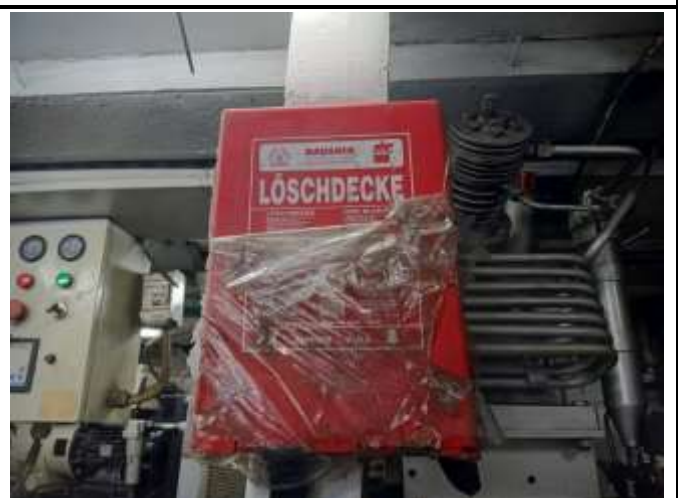
- 2x located in each guest cabin in the lower deck except for cabin No.8 which had only one blanket (total of 15 blankets)
- 1x in the galley
- 2x inside the engine room.

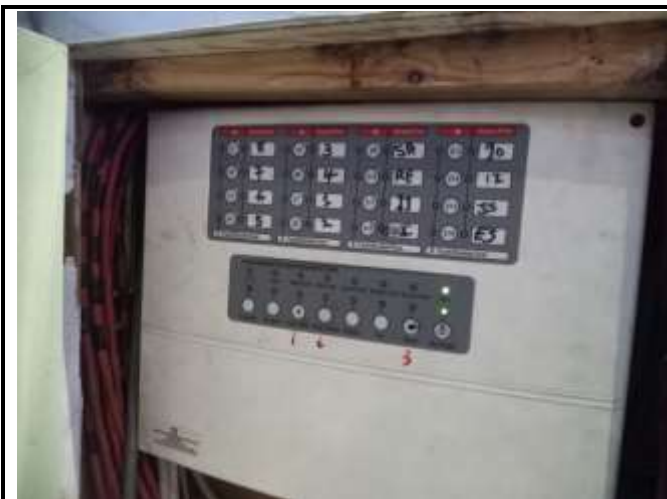
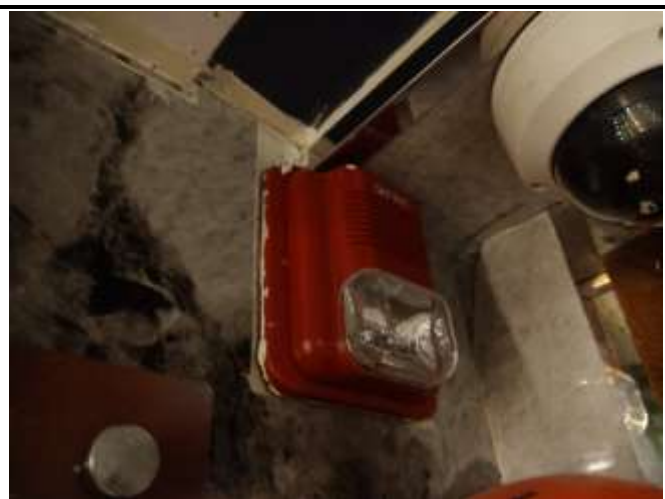
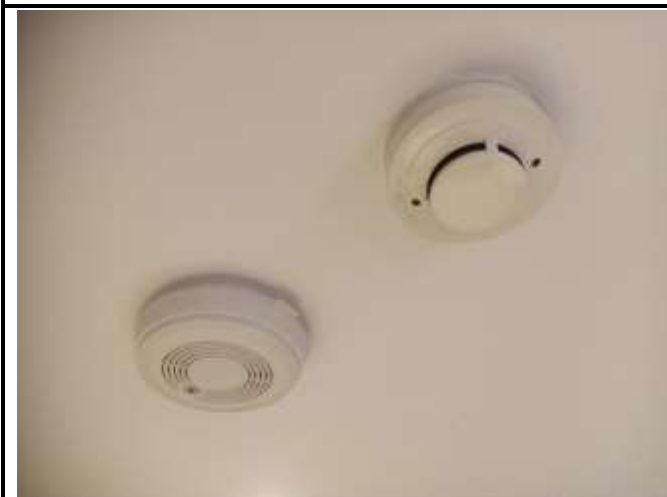
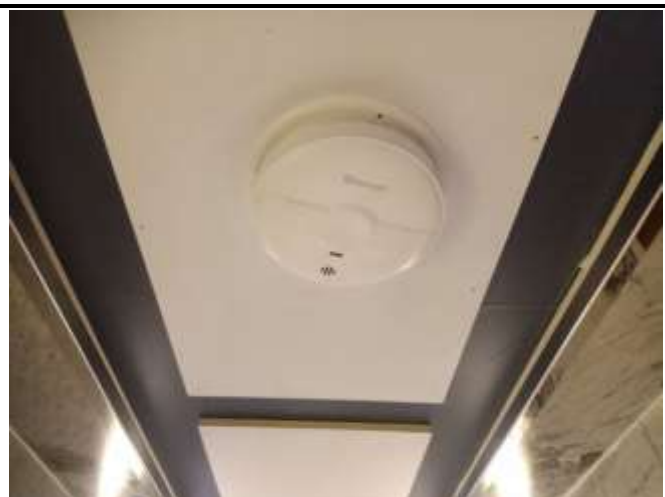
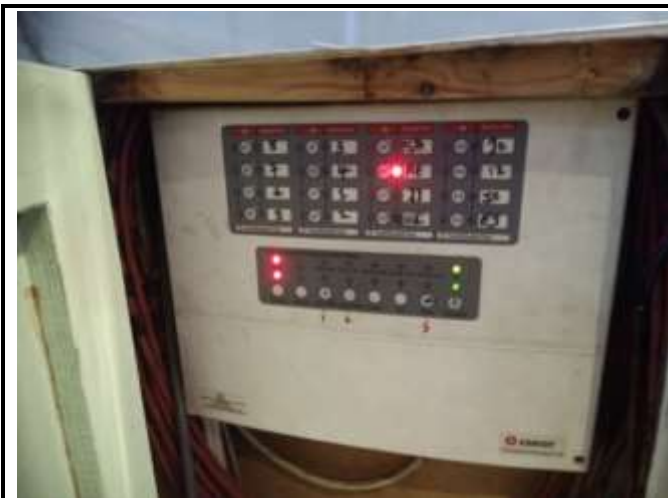
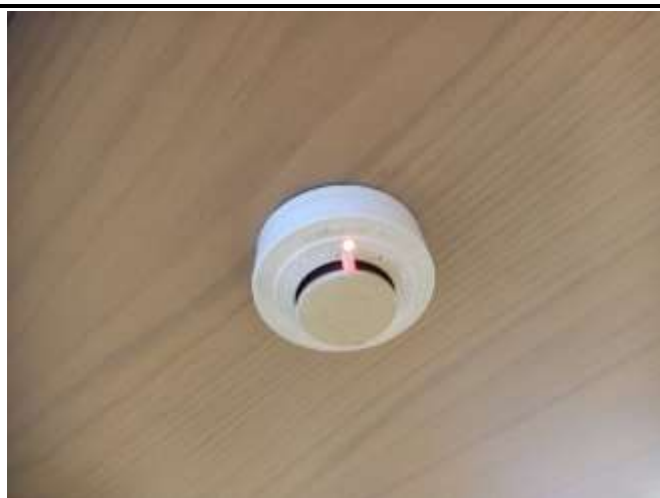
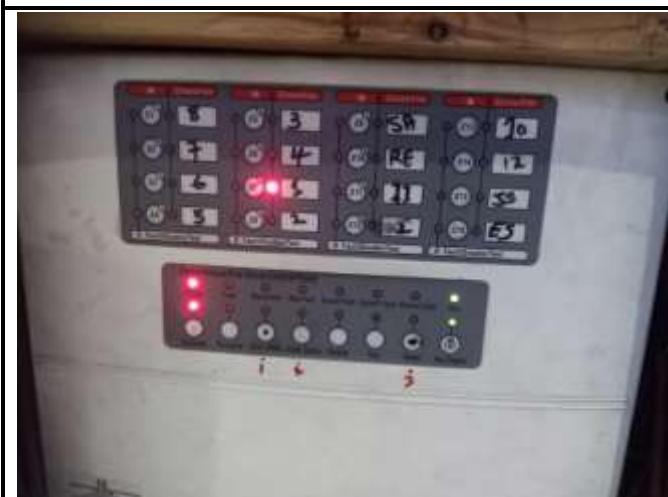
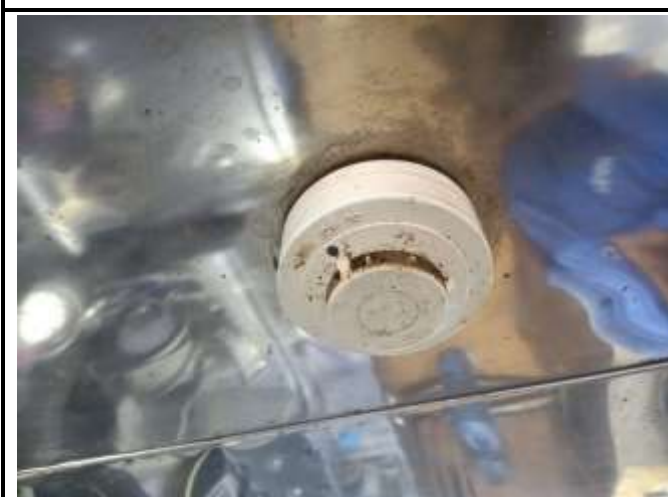
A **CONVOY fire detection and alarm system** is installed onboard, with the main control panel located in the saloon. Smoke and heat detectors are strategically positioned throughout the vessel — including the navigation cabin, upper deck, saloon, galley, all accommodation cabins, and the engine room — providing broad and effective coverage.

During the inspection, the fire panel's indicator lights were tested and confirmed to be fully functional. Additionally, both the audible alarm and a sample of connected detectors were tested, verifying that the system is in good operational condition at the time of the survey.

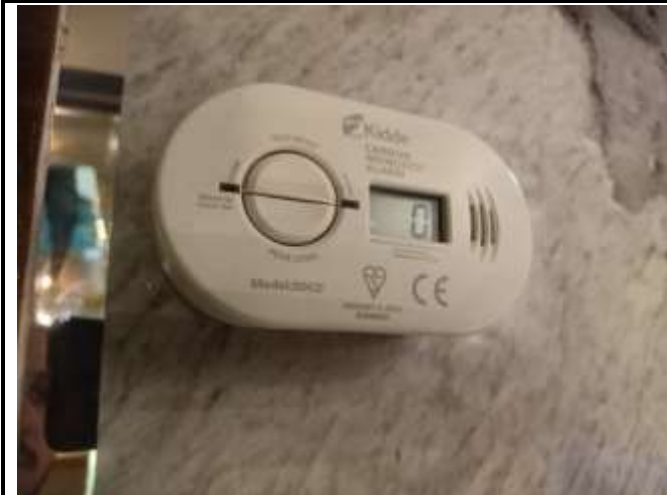
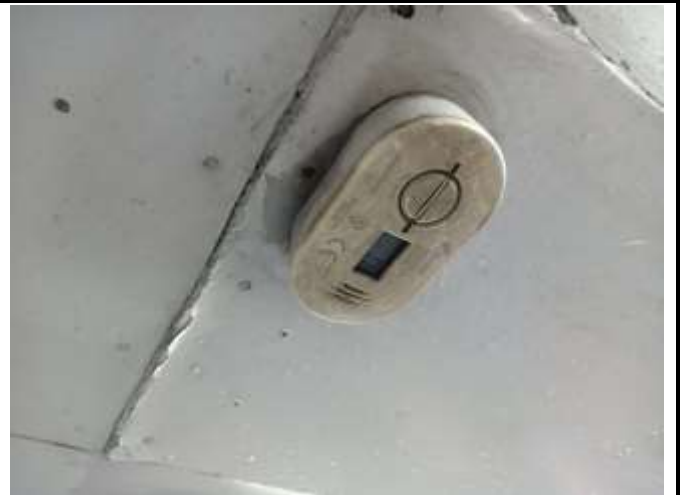
Additionally, **carbon monoxide alarms** are installed on the lower deck — one in the corridor outside the guest cabins and another inside the engine room. Both alarms were tested during the inspection and confirmed to be operational.

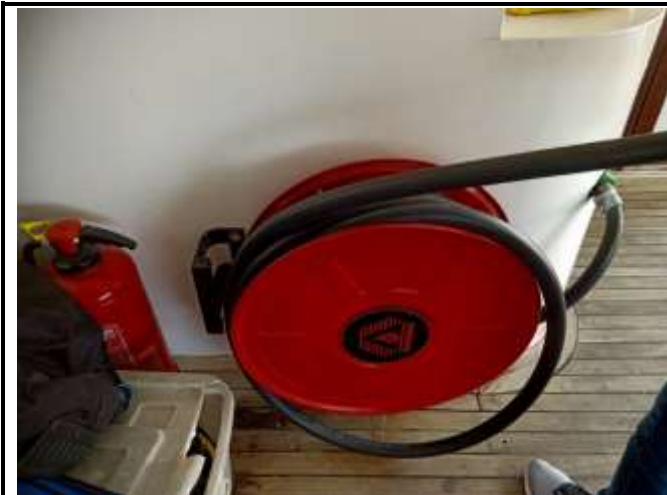
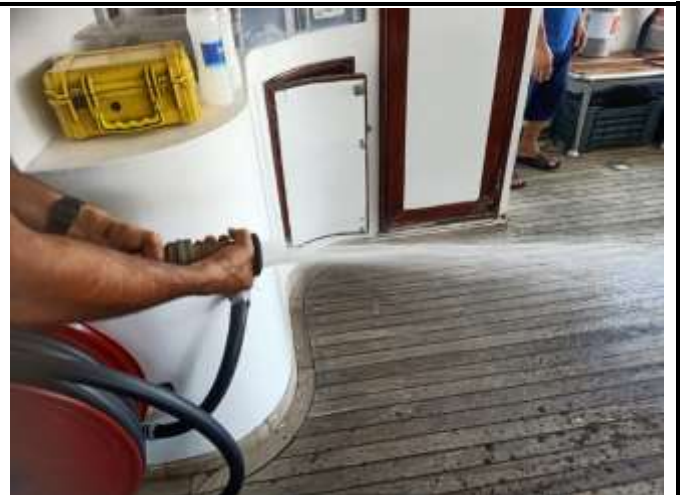
The **fire hose system** was also tested and found to be in proper working condition, delivering sufficient water pressure to support an effective firefighting response.

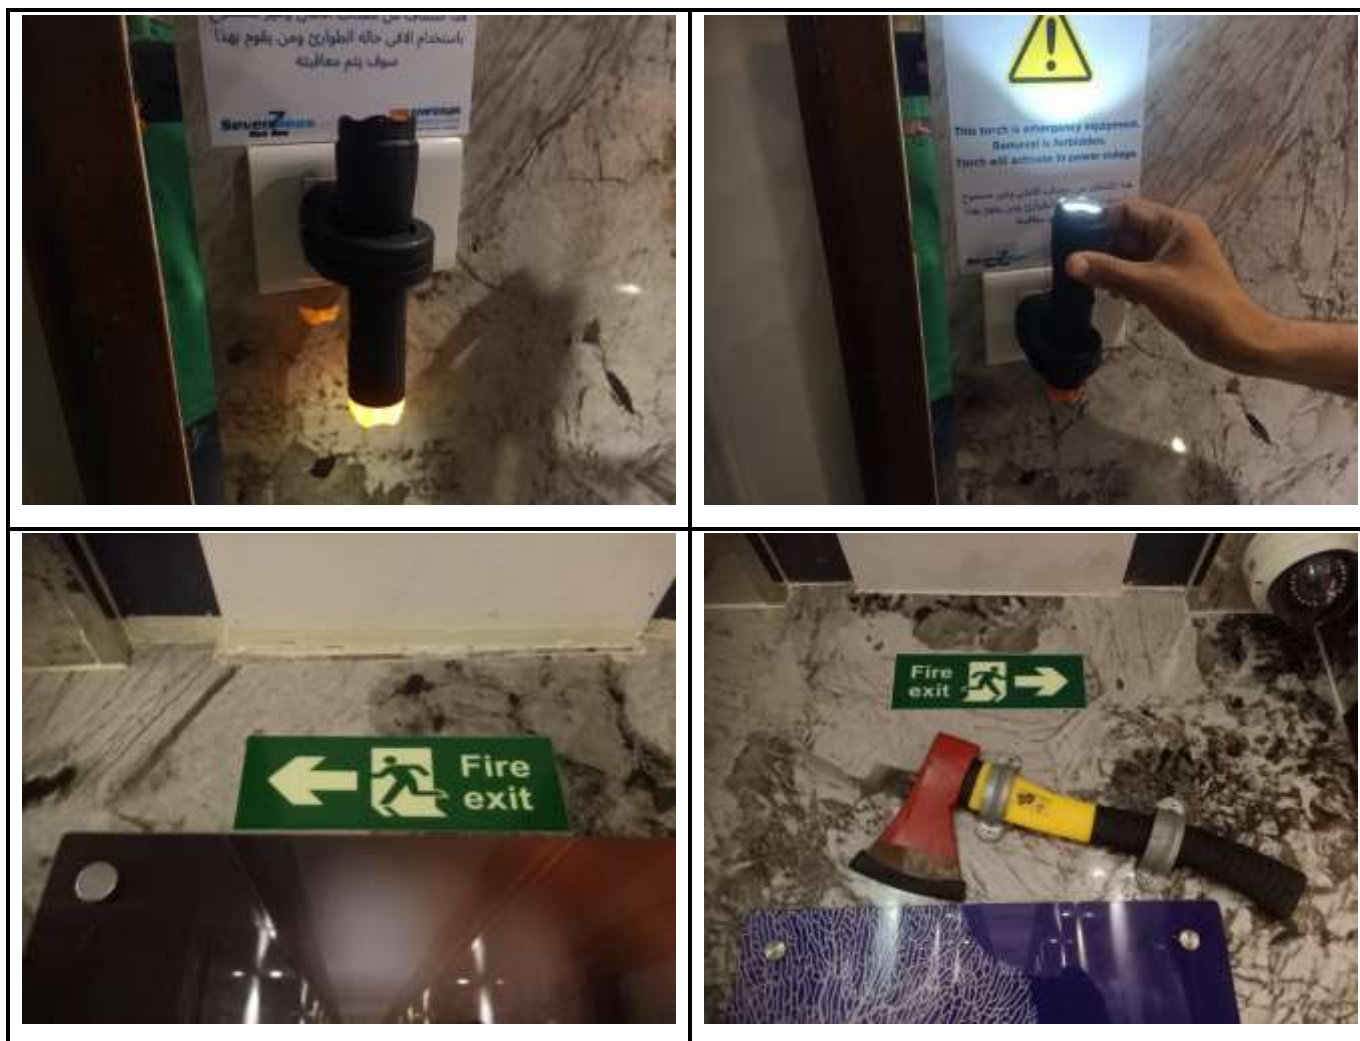
The **evacuation plan** was found posted inside all accommodation cabins, providing clear guidance for emergency situations. The primary emergency exit for the lower deck is located in **Cabin No.7**, and the designated escape route was clearly marked throughout the vessel.

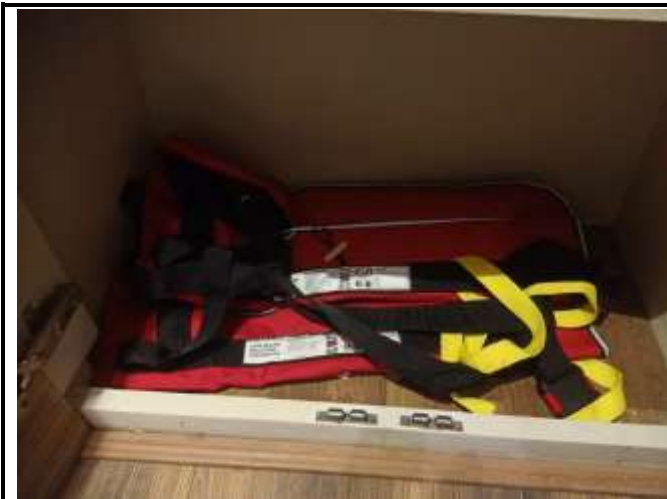
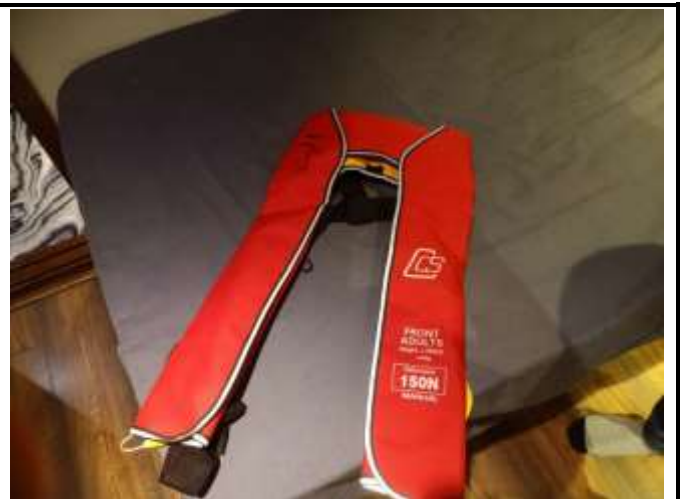
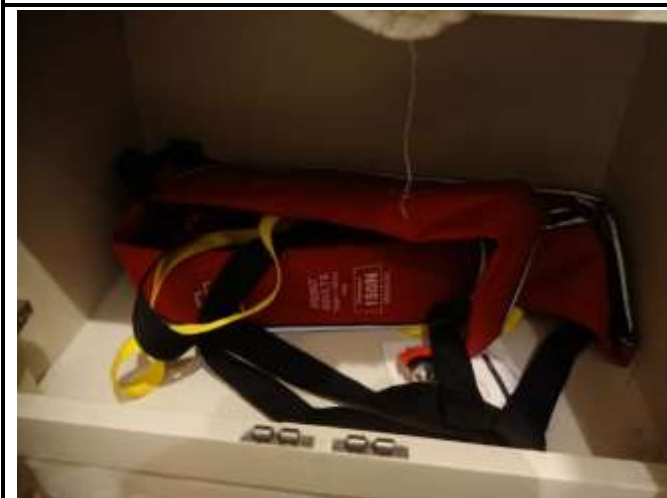
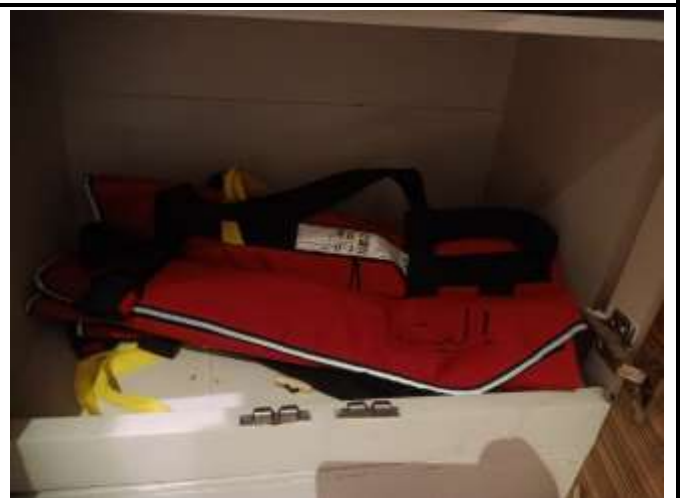
All appliances were visually inspected and found in good condition with no visible remarks. The last inspection for the life rafts was carried out on **January 4, 2025** as stated in the life raft certificate.

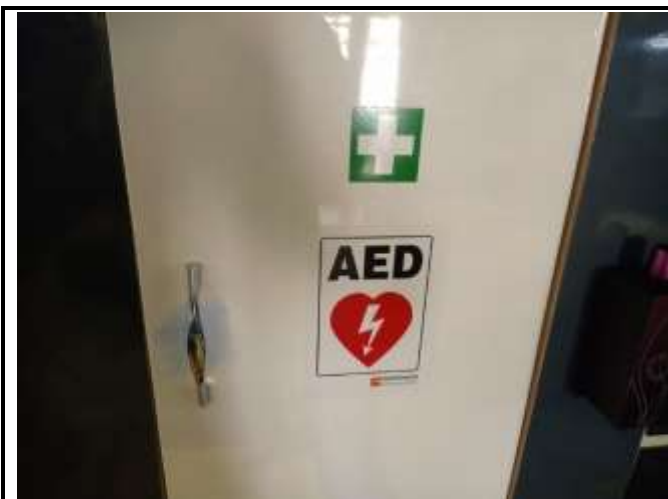
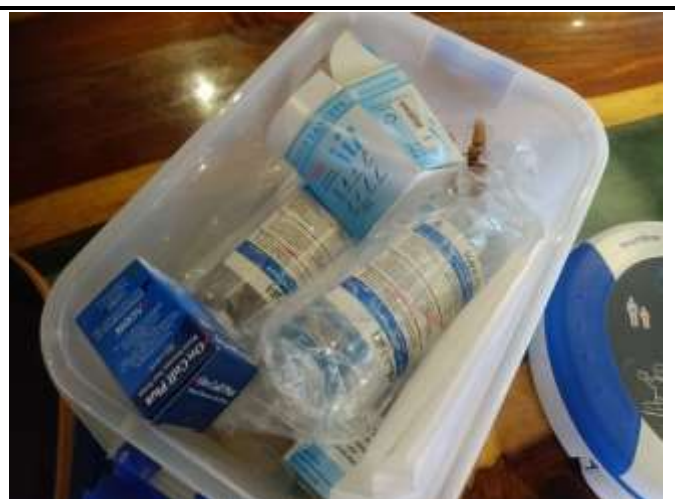
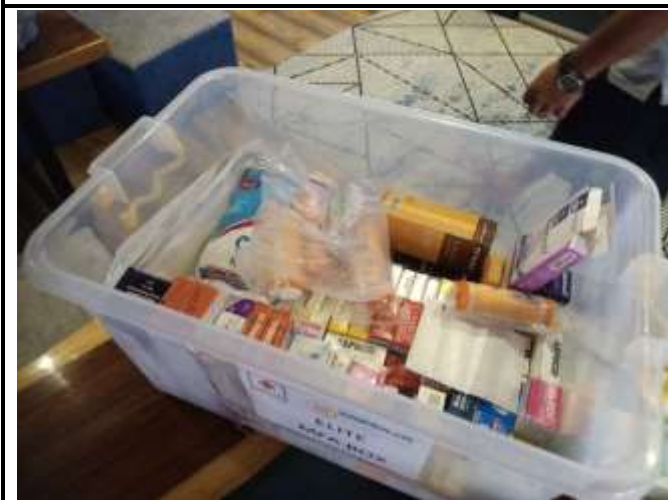
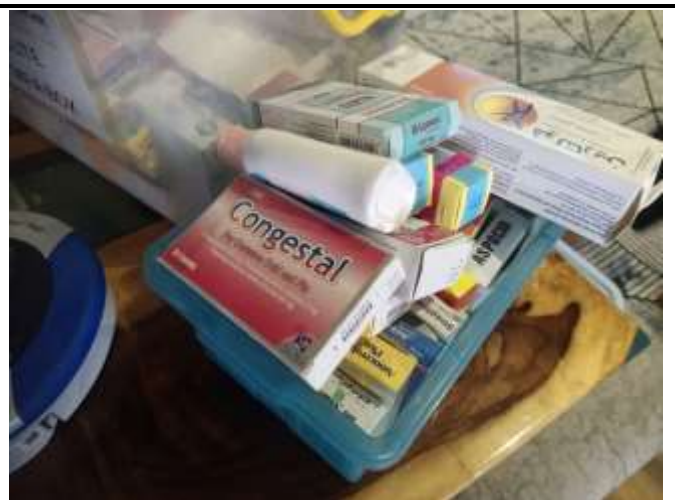
First aid, medical box and the oxygen bottle were inspected, all medicines were found valid and well stored.
