Bachelor-thesis

Investigation of a series of accidents involving yachts for diving vacations

degree: Naval architecture

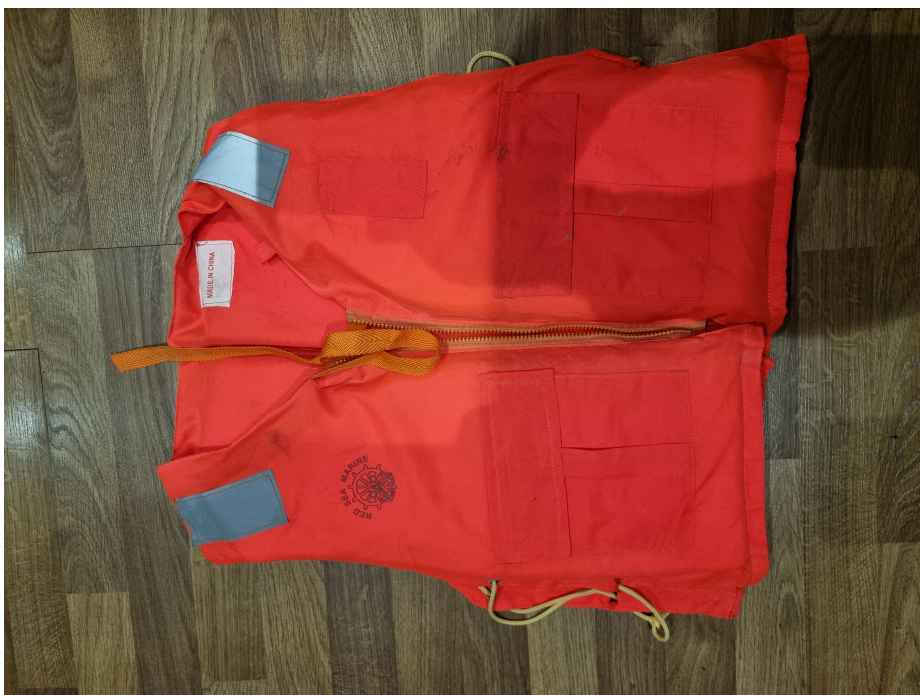
These guidelines are not always adhered to on liveboard vessels either. For example, the lifejackets on the „Emperor Elite“ are very simple and do not comply with the regulations, e.g. they do not have a collar (Fig. 18). This is not an isolated case. The lifejackets on the „Carlton Queen“ are also said to have had no collar [87]. Correct lifejackets have collars and can usually be stacked (Fig. 19).

Figure 18: Lifejacket on the „Emperor Elite“

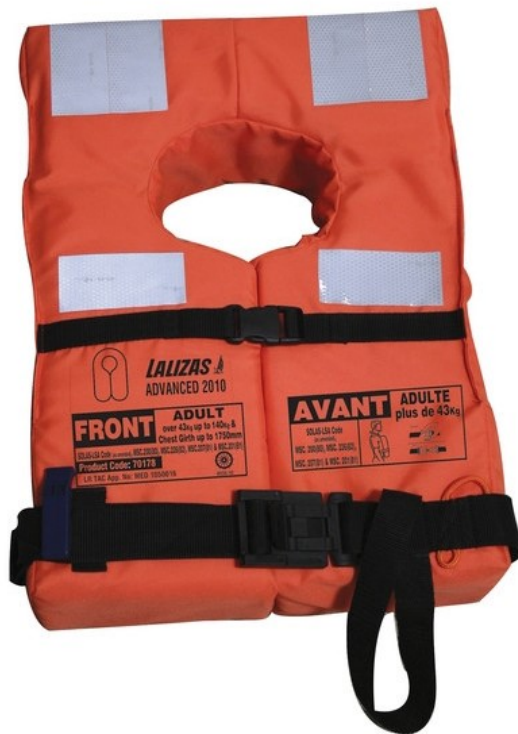
Figure 19: Example of a lifejacket according to SOLAS-Konvention [120]

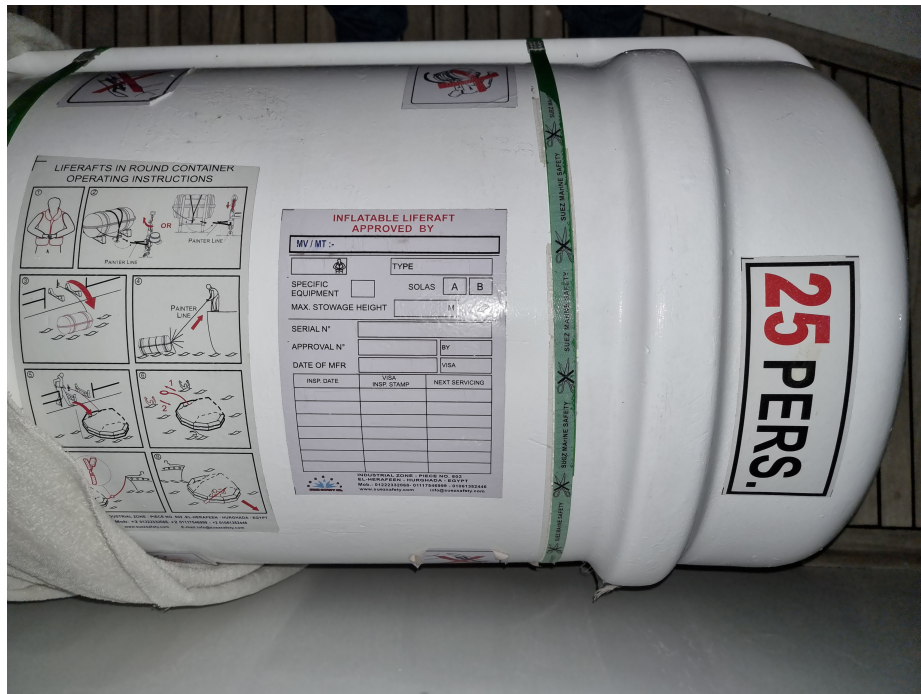
These markings are also not filled in for the „Emperor Elite“ (Fig 20) and therefore no statement can be made about the functionality of the liferaft.

Figure 20: Plaque of a life raft on the „Emperor Elite“

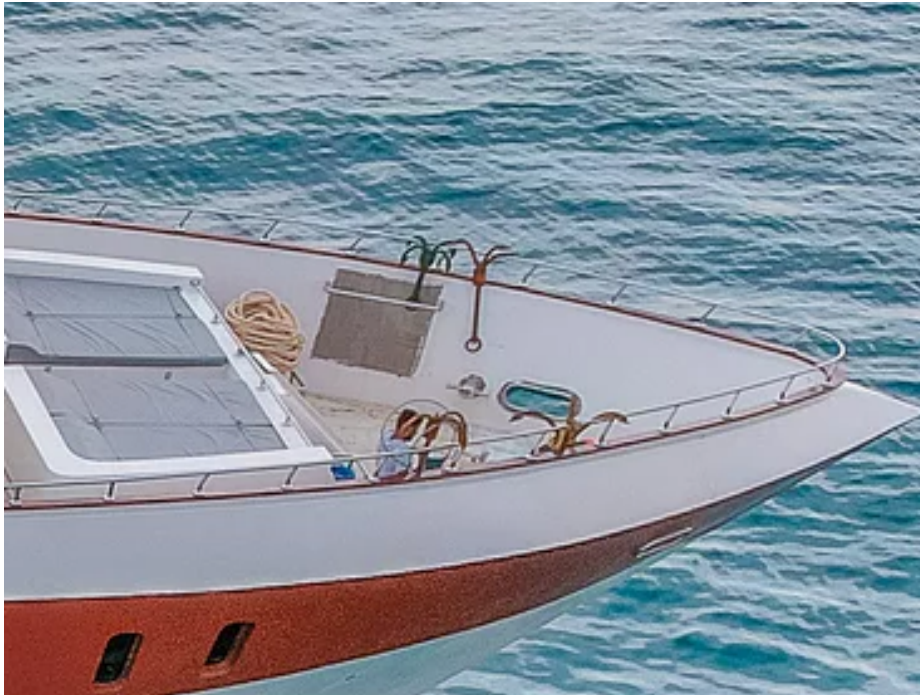
Many liveaboard vessels do not have large anchor systems. There are only cleats in the foredeck for the mooring lines in the reefs [89]. Small anchors are sometimes used for the reefs, such as on the „Ghazala Explorer“ (Fig. 26). Anchors are needed to be able to hold position in an emergency if the engine fails, even if they are not regularly used for anchoring. For example, the accident involving the „Omneia Soul“ or the „Emperor Echon“ could possibly have been prevented by deploying additional anchors.

Figure 26: Anchor on the „Ghazala Explorer“ (Cropped from an image by [116])
