***INSPECTION REPORT FOR FIREFIGHTING
APPLAINCES ONBOARD***

M/Y “EMPEROR ELITE”

PORT GHALIB
MARSA ALAM,
EGYPT

ON
24th July, 2025

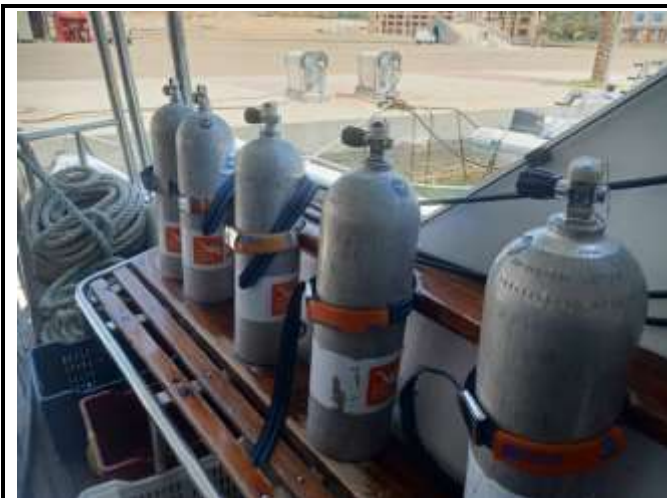
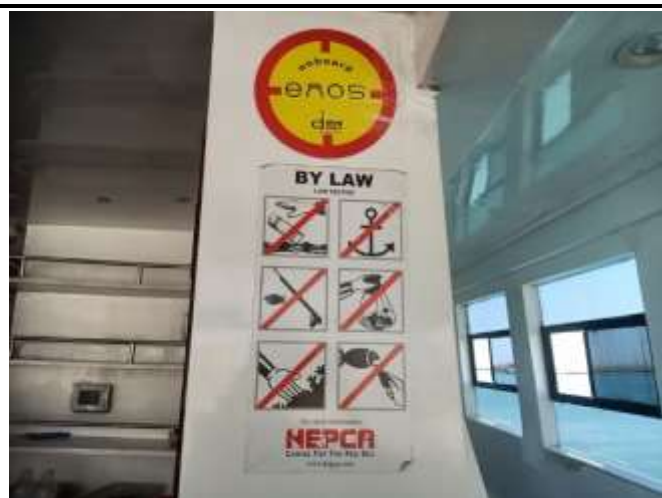
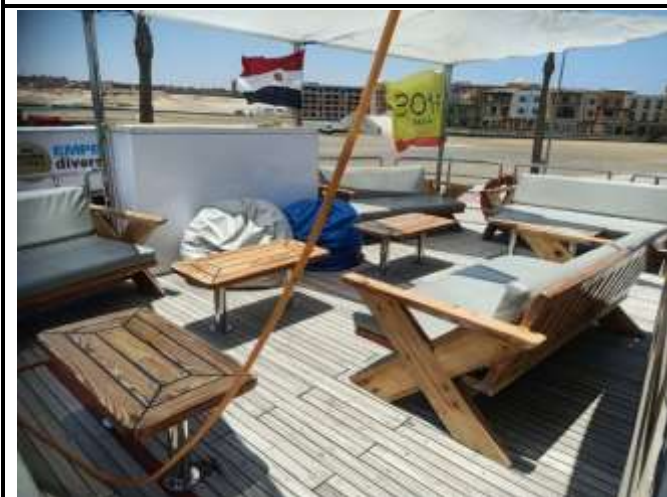
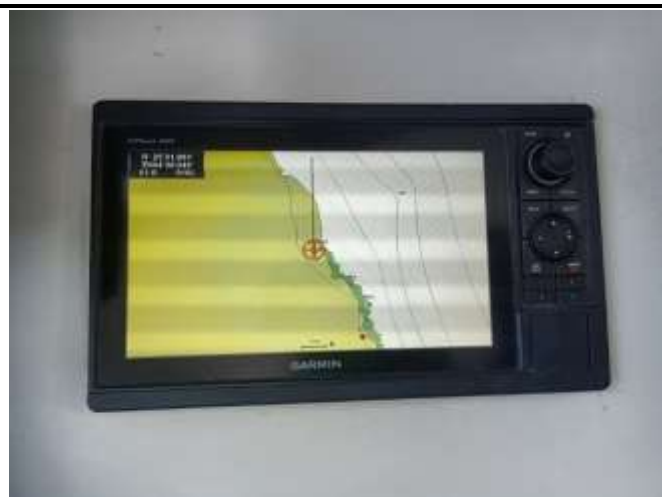
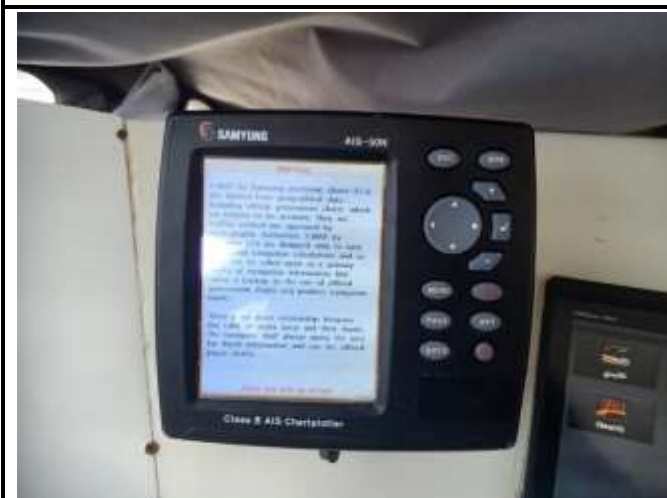
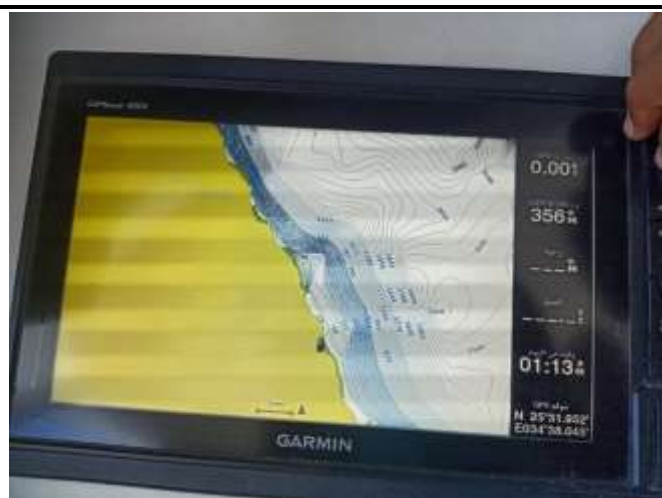
A thorough visual inspection was carried out across all accessible areas of the liveaboard yacht, including guest accommodations, crew quarters, galley, engine room, safety equipment stations, communal areas, exterior hull, and all deck levels. The vessel was found to be in overall satisfactory condition, with no visible deficiencies, safety hazards, or structural irregularities observed at the time of inspection. Housekeeping standards were well-maintained, and all accessible systems, fixtures, and fittings appeared to be well-maintained and in sound operational condition.

The navigation equipment—including the GPS, radar, and VHF communication systems—was visually checked and found to be in place and generally well-maintained. However, it was observed that the echo sounder was not functioning properly during the inspection, as no depth reading was displayed on the unit. This issue should be investigated and rectified to ensure safe navigation, especially in shallow or unfamiliar waters.

- Investigate and rectify the malfunctioning echo sounder to ensure navigational safety.
- Update the firefighting equipment certificate to reflect the actual onboard inventory and replace the expired fire extinguisher balls.
- Maintain proper documentation of fire drills and safety briefings for audit and verification purposes.
- Ensure regular review and verification of safety equipment inventory against certification records to maintain compliance.

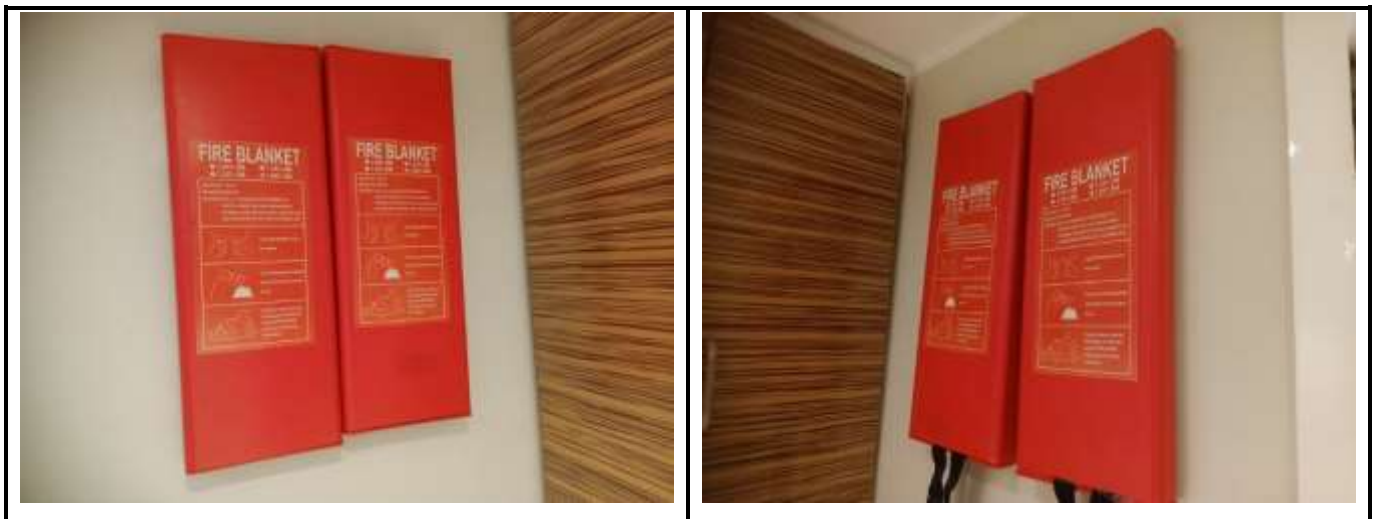
The yacht is also provided with a total of **18 fire blankets**:

- 2x located in each guest cabin in the lower deck except for cabin No.8 which had only one blanket (total of 15 blankets)
- 1x in the galley
- 2x inside the engine room.

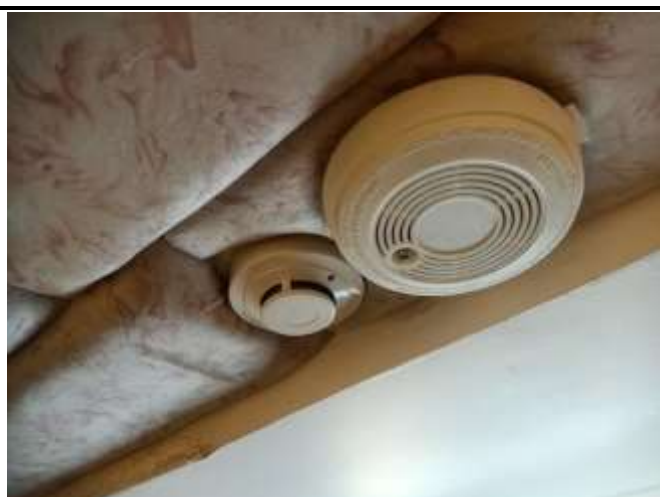
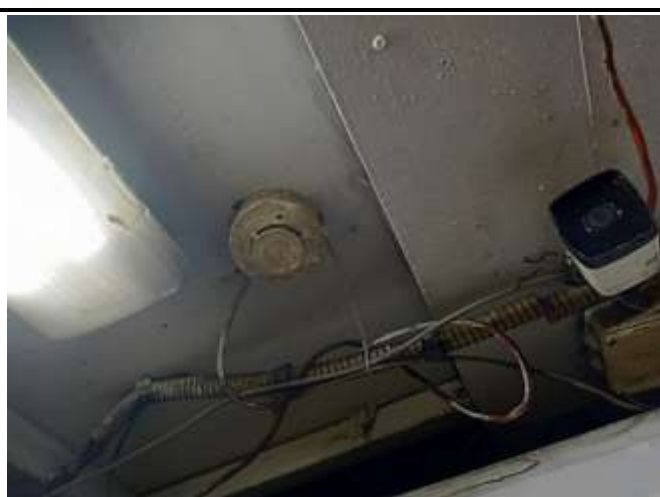
Additionally, **carbon monoxide alarms** are installed on the lower deck — one in the corridor outside the guest cabins and another inside the engine room. Both alarms were tested during the inspection and confirmed to be operational.

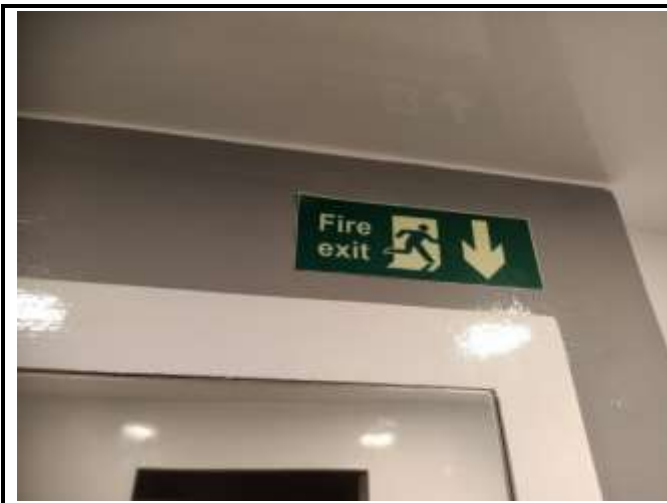
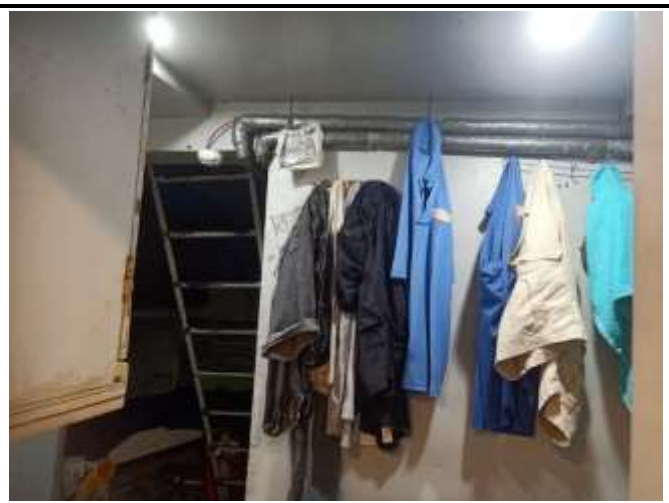
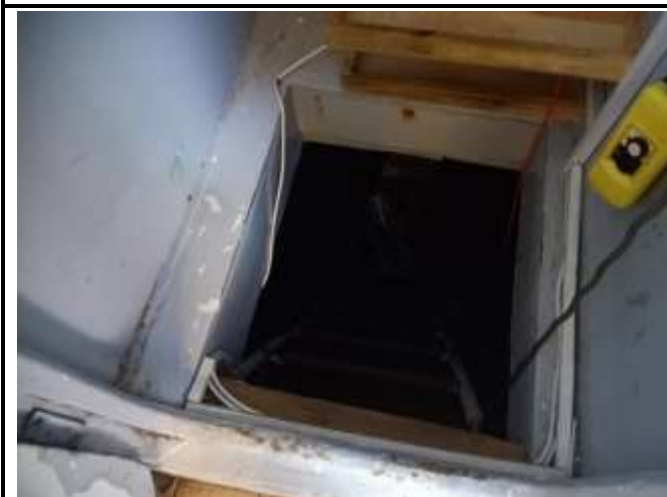
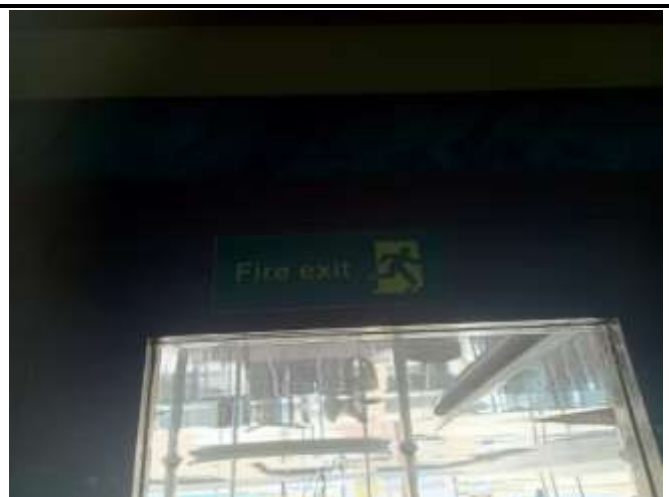
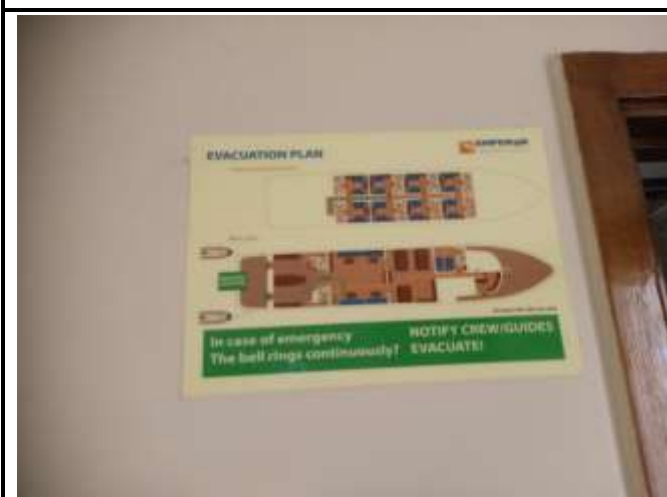
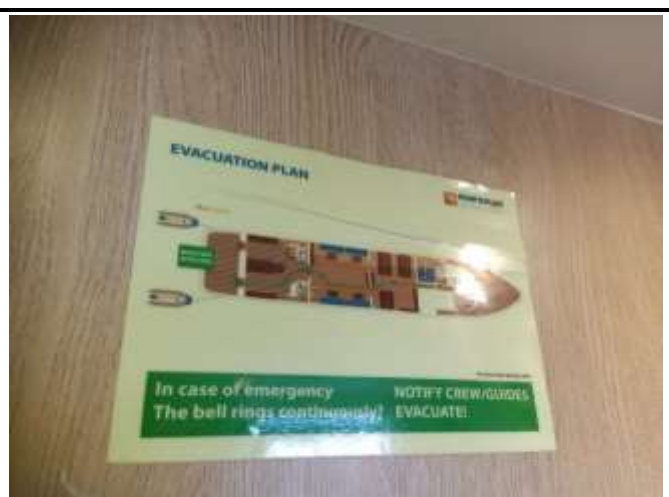
The **evacuation plan** was found posted inside all accommodation cabins, providing clear guidance for emergency situations. The primary emergency exit for the lower deck is located in **Cabin No.7**, and the designated escape route was clearly marked throughout the vessel.

Additionally, the corridor on the lower deck is equipped with two emergency torches, positioned at both ends to aid visibility during power outages or low-visibility conditions.

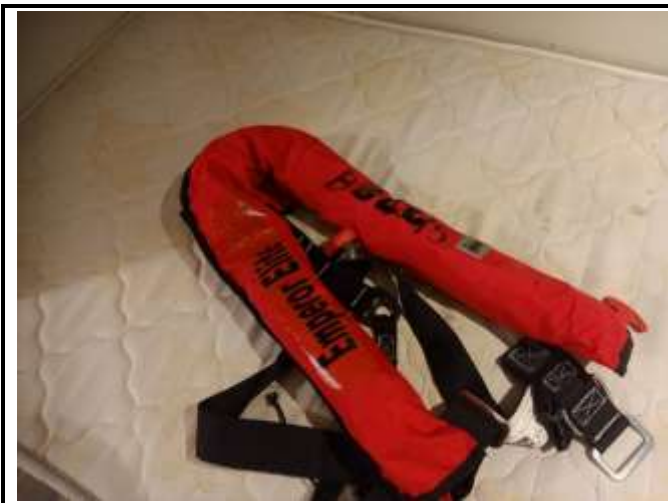
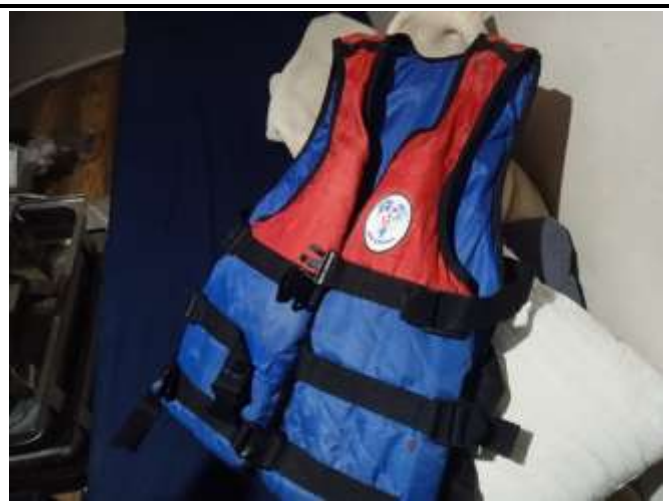
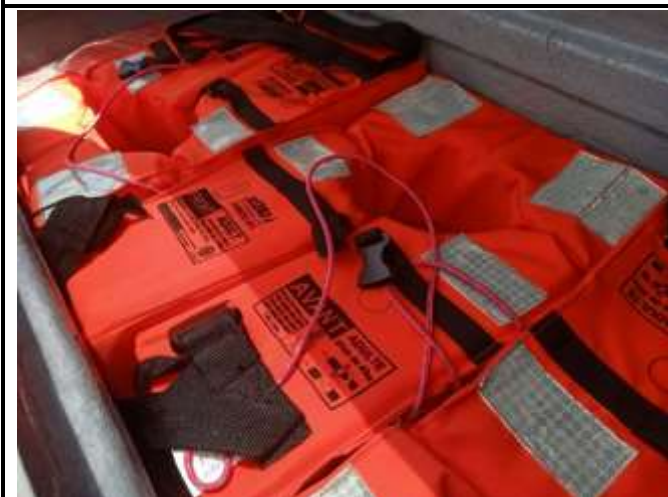
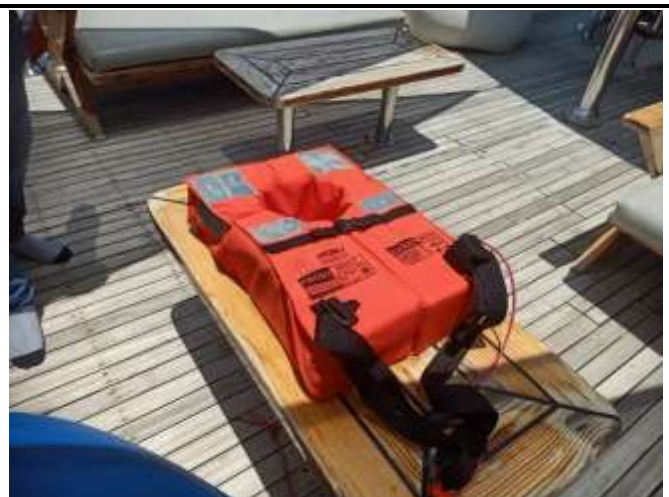
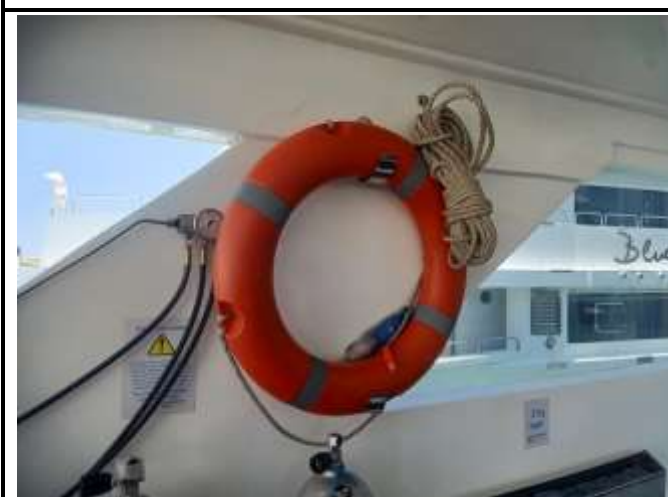
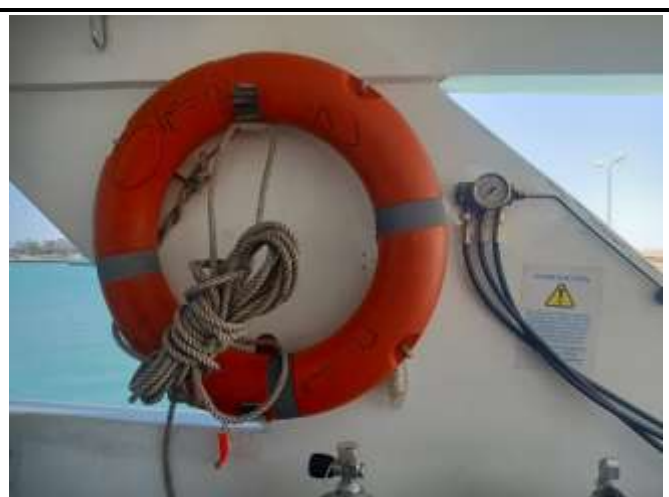
- 68x life jackets, stored in each cabin (2x per cabin), and on the upper deck.
- 8x life buoys, each with a 30 meters' rope.
- 1x Safe link SART
- 1x EPIRB
- 2x life rafts, each with a capacity of 25 persons.
- 2x tender boat.

All appliances were visually inspected and found in good condition with no visible remarks. The last inspection for the life rafts was carried out on **January 4, 2025** as stated in the life raft certificate.
